REPORT ON THE FIRST FUMIGATION OF A CHURCH IN EUROPE USING SULFURYL FLUORIDE

DR. GERHARD BINKER
Binker Material Shultz, Nurnberg, Germany

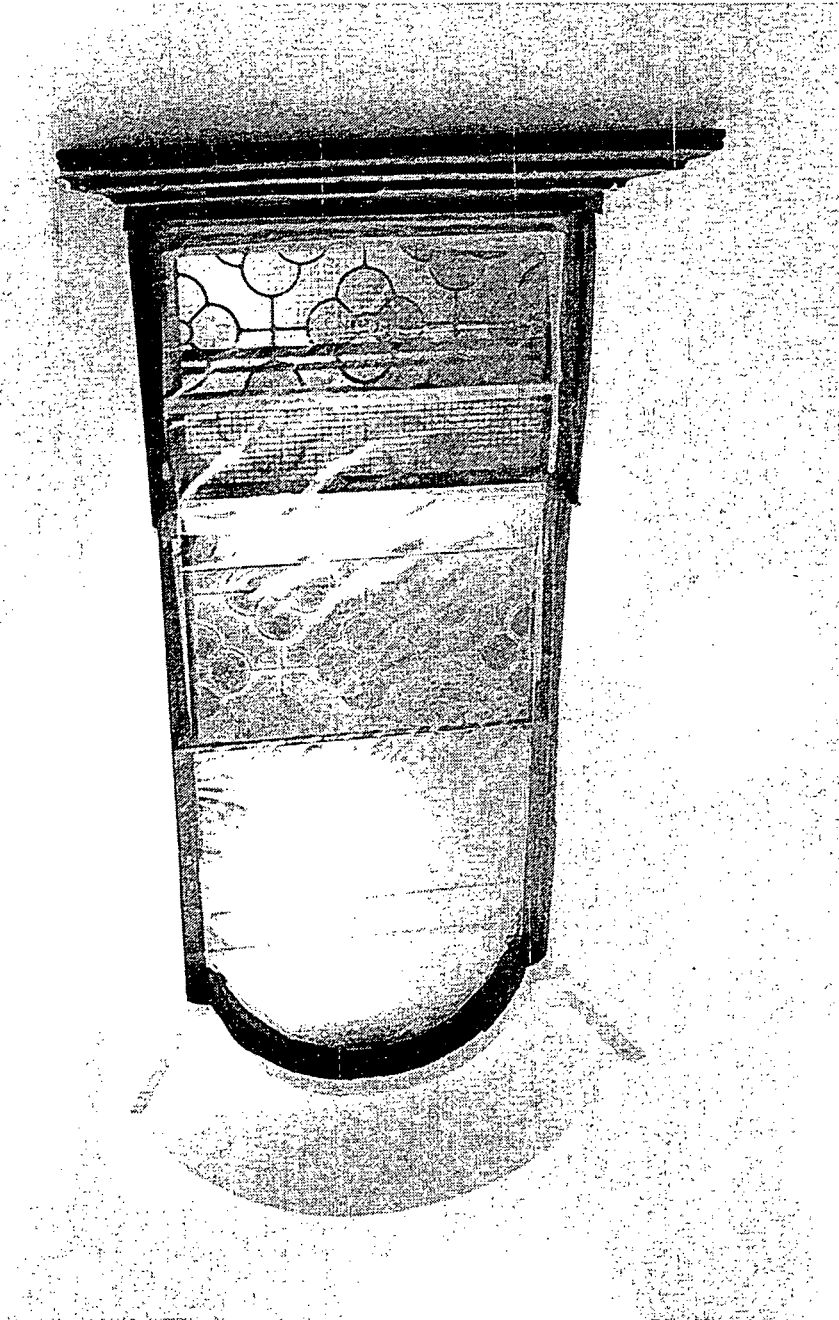
Fig. 3. A sealed window of the church to prevent gas loss

The church was sealed by the tape and seal technique. Using this procedure, all windows and doors were covered with poly and all cracks and crevices were sealed with a special adhesive paper.

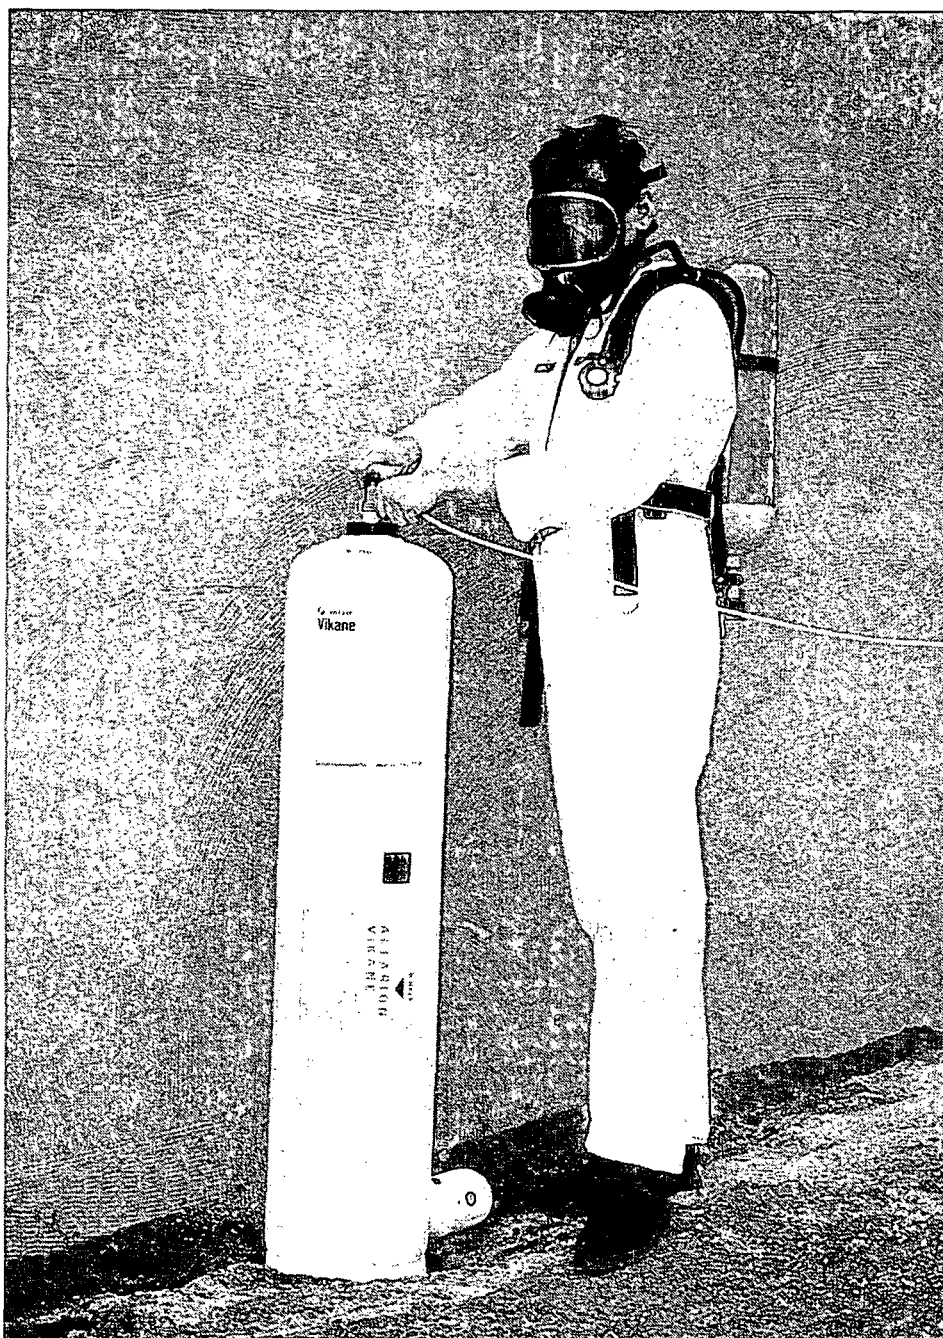
Fig. 4. Releasing the sulfuryl fluoride from the cylinder

The sulfuryl fluoride was released from a cylinder outside the structure through an application hose with a filter to remove impurities from the sulfuryl fluoride.

The fumigant was directed toward efficient fans, which ensured rapid and uniform distribution. To avoid damage caused by a “fog-out” of the gas, it was also important not to exceed the shooting

rate of 1 kg SO₂F₂/min (= 2.2 lb/min). After the gas shooting was finished, the church was checked for leaks with an Interscan Gas Analyzer, a monitoring device capable of measuring sulfuryl fluoride concentrations between 1 and 50 ppm. No serious leaks were detected as a result of the careful sealing. Additionally, each day the gas concentration outside the church near the adjacent dwelling houses was measured frequently, while the actual concentration within the fumigation site was monitored with a Fumiscope, an instrument capable of measuring sulfuryl fluoride concentrations in oz/1000 ft³.
